FACILITIES PLANNING
STUDY CONSULTATION

TREMPEALEAU
COUNTY
PROPERTIES

January 9, 2017

Building Assessment – Trempealeau County Government Center

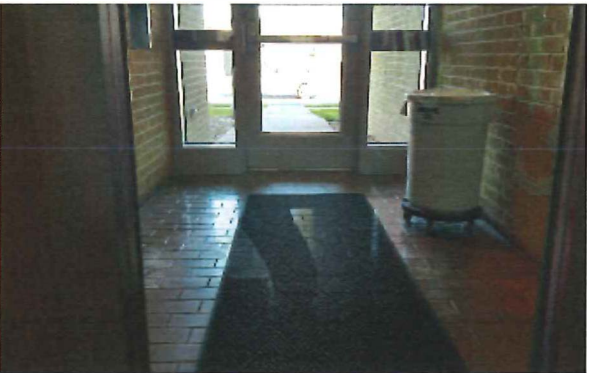
P-1

Flooring throughout the facility consists of many differing products, from soft tile to hard tile to carpet and terrazzo. Generally, the areas soft tile and carpet at most locations is showing considerable wear and has reached its useful life expectancy.

As a component of any renovation project these products will be replaced with new floor systems.

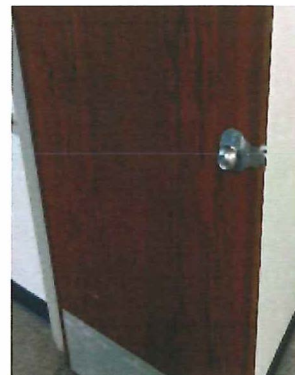
P-1

The existing interior doors typically are wood. In most areas of the facility the doors are in good condition; however, some doors are damaged and showing signs of wear – typical with age and use. Also, some doors with-in the facility have had A.D.A. compliant lock-sets installed; however, the majority are lacking this update.

As a component of any renovation project, consideration should be given to the replacement of heavily worn units. During that process door hardware must be upgraded to current code compliancy.

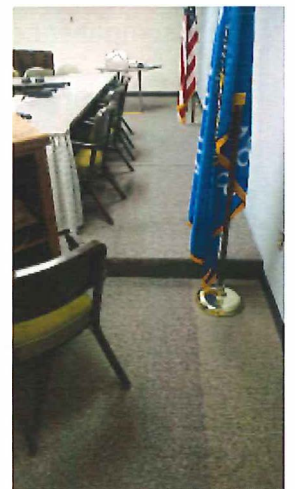
- i. Due to the 1995/96 renovation most all of the present areas of the facilities meet the intent of the A.D.A., a few areas still needing attention are:
- ii. **Dias at Board Room:**
Currently there is a step up for access – a ramp should be provided.
- iii. **Door Hardware:**
As previously reported.
- iv. **Countertop Heights:**
Most countertops are set at a height of 36" – present code requires maximum height of 34".
